## Various Disc Caliper Noise Problems

Recently we have had questions arise as to the noise problems with various calipers. The Bendix center abutment caliper (Figure 1) used on many Ford Pintos (since 1971) and newer Chevrolet and GMC 1-ton trucks have this problem of noise. In this bulletin you will find replacement keys for the Chevrolet and GMC 1-ton trucks.

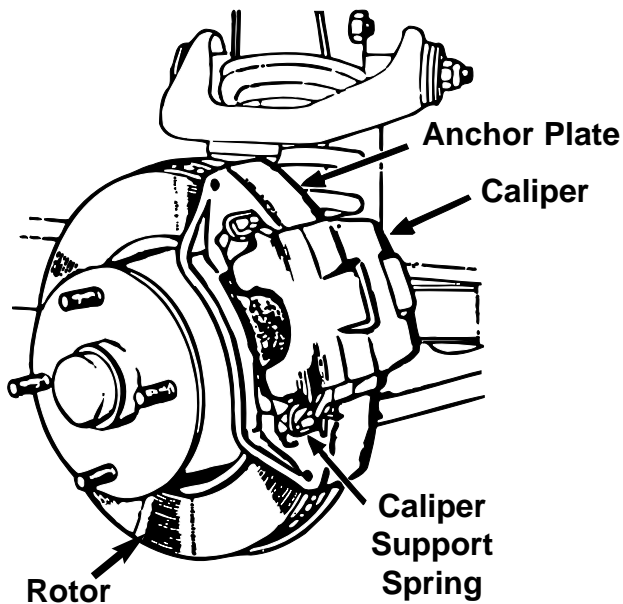
Figure 1

The caliper design is a single piston rail slider. In some instances, wear can occur between the caliper, steering knuckle and support key. This wear creates excessive clearance allowing fore and aft movement of the caliper. This movement can cause excessive vibration resulting in noise. If left unattended, damage to other brake components could result.

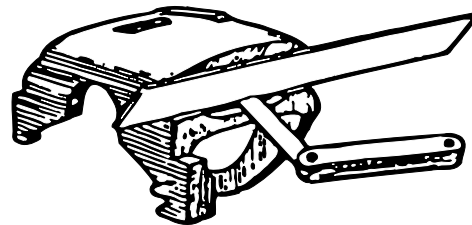
Figure 2

After cleaning caliper housing, lay a straightedge across the support key contact area (see Figure 2).

Using a feeler gauge measure the depth of wear in this area. If the measurement exceeds .050", replace the caliper. If the original caliper is to be reused, overhaul caliper before reinstallation. Replace all worn parts, and clean caliper using crocus cloth and brake fluid.

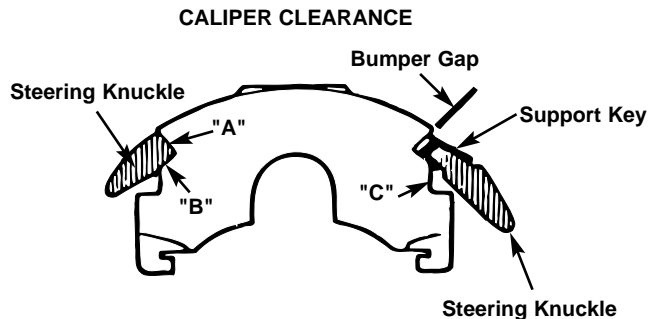
**Figure 4**

Temporarily-install new or existing caliper into the steering knuckle along with a new support key. **DO NOT** install support spring. Insert screwdriver blade into bumper gap area and pry upward on caliper. Surfaces A, E3, and C (Figure 4) of caliper should seat firmly against steering knuckle. Measure bumper gap with thickest feeler gauge that will fit when inserted lengthwise.

Select the correct oversize key using chart below (Figure 5). Also note key location on Figure 6.
