SERVICE TIPS FOR THE PROFESSIONAL TECHNICIAN

1988-1990 One Ton Chevrolet Trucks Chevrolet Truck Brake Noise

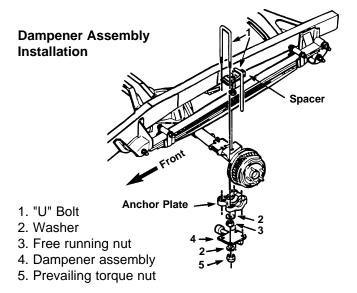
A moan or howling noise may be heard during brake application at low speeds on some 1988-1990 one ton Chevrolet Trucks, both two wheel drive and four wheel drive models. The noise is caused by normal brake drum vibrations which make the rear brake backing plates oscillate at an audible frequency. This noise will not damage or destroy any of the vehicle components. To correct this condition, General Motors has modified the rear axle assemblies on C30 and K30 trucks in order to change the resonant frequency. Vehicles built after the following VIN brake points have the new axle assemblies already installed: VIN: 1 GCGK34N6LE244095 -Pontiac East Assembly Plant

To correct this condition in service. a tuned dampener assembly has been developed. When installed at the rear leaf spring "U" bolts, the dampener will oscillate 180 degrees out of phase with the resonant frequency, effectively eliminating the generation of the noise.

Refer to the following service procedure in Figure

- 1. Be sure to take all safety precautions, then raise the vehicle on a hoist and support the rear axle independently to relieve the tension on the leaf spring.
- 2. Remove the existing nuts and washers from the "U" bolts.

- 3. Remove the existing anchor plates.
- 4. Remove existing "U" bolts and existing spacers.
- 5. Clean anchor plates, spacers and axle mating surfaces with a wire brush.
- 6. Install spacers and replacement "U" bolts (1).
- 7. Install anchor plates.
- 8. Install replacement washers (2) and free running replacement nuts (3).
- 9. Torque nuts to 20Nm (15 ft. lbs.), then tighten them in a diagonal sequence to a torque on 160 Nm (188 ft. lbs.).
- 10. Install dampener assembly (4) with the dampening arm toward the driveshaft (Figure 1).
- 11. Install replacement washers (2) and existing torque nuts (5).
- 12. Torque nuts to 20Nm (15 ft. lbs.), then tighten them in a diagonal sequence to a torque on 160 Nm (188 ft. lbs.).
- 13. Remove axle support and lower hoist.
- 14. Road test vehicle to verify the repair.
