## ABS WARNING LAMP ILLUMINATES INTERMITTENTLY 1993 (LH) CHRYSLER CONCORD. DODGE INTREPID, EAGLE VISION

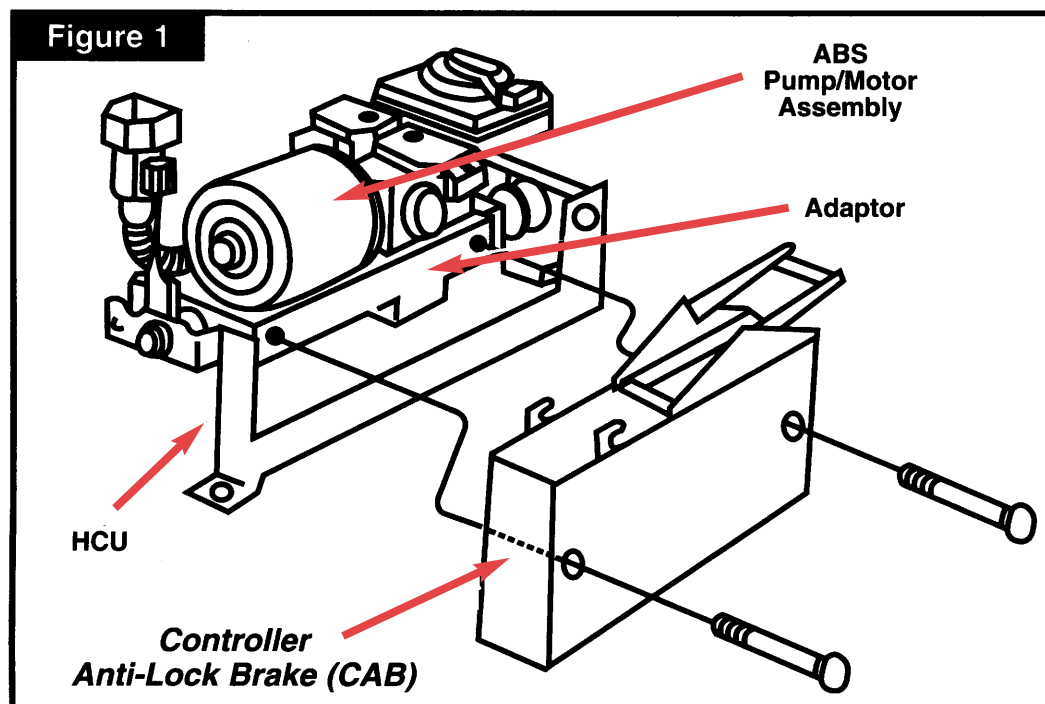
Electrical “noise” created by some combination of accessories may cause the ABS amber warning lamp to illuminate intermittently, even though there is actually no problem with the Teves Mark IV anti-lock brake system.

The Controller-Anti-Lock Brake (CAB) aluminum adaptor (see Fig. 1) must be replaced with a polyamid/plastic adaptor and an adhesive patch must be installed (see Fig. 2).

If an aluminum adaptor is present between the CAB and the housing of the Hydraulic Control Unit (HCU), it must be replaced with the appropriate kit. If the polyamid adaptor is already present, proceed to step 17.

10. Replace the aluminum adaptor with the polyamid adaptor along with the two new bolts in the kit (female indentations in the adaptor mate to the male nibs on the HCU). Torque the two bolts to 10-14 Nm (88-124 in. lbs.)
