## 1988 AND LATER GM "C" AND "K" TRUCKS

### CLUTCH MASTER CYLINDER FAILURE

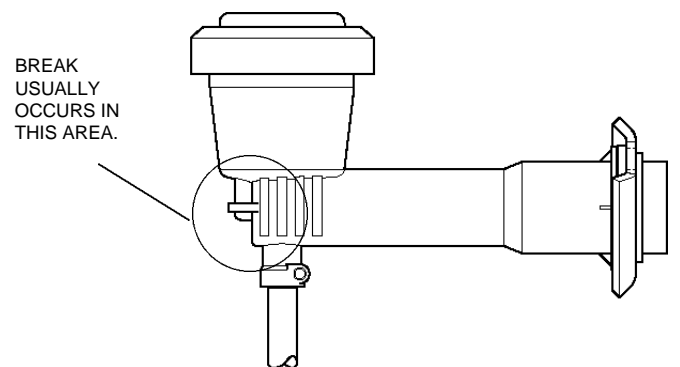
TYPICAL CLUTCH MASTER CYLINDER

The clutch master cylinder can break due to excessive pressure buildup. The break can begin as a small crack creating a leak, which can later develop into a visible crack in the master cylinder housing. This is often mistakenly diagnosed as a defective master cylinder, especially after repeated failures.

The most common cause has been reported to be a binding clutch fork, or throw out lever. If the area of contact between the ball stud and the clutch fork is binding, from lack of lubrication, hydraulic pressure in the clutch system can rise substantially. Excessively high pressure can cause the master cylinder to leak.

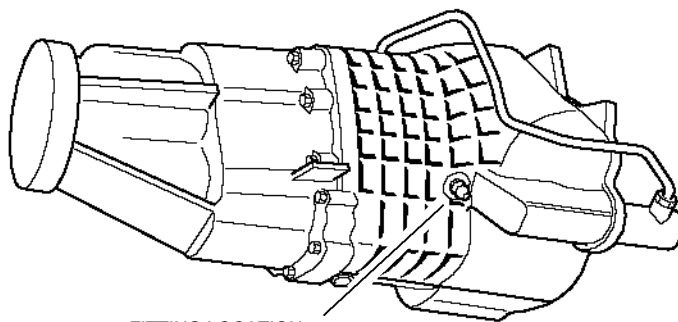
FITTING LOCATION  
(IF EQUIPPED).

Some 1994-95 vehicles are not equipped with the grease fitting to lubricate the ball stud. The General Motors bulletin pertains to these vehicles.

The ball portion of the ball stud should be coated with high temperature grease. The ball stud should then be packed with grease from the grease fitting, if equipped. The grease fitting may not be readily visible on high mileage vehicles and may require cleaning away of road dirt to make the fitting visible and serviceable.
