## 1984 to 1987 Mercury Lynx and Topaz 1984 to 1987 Ford Escort and Tempo Brake Noise

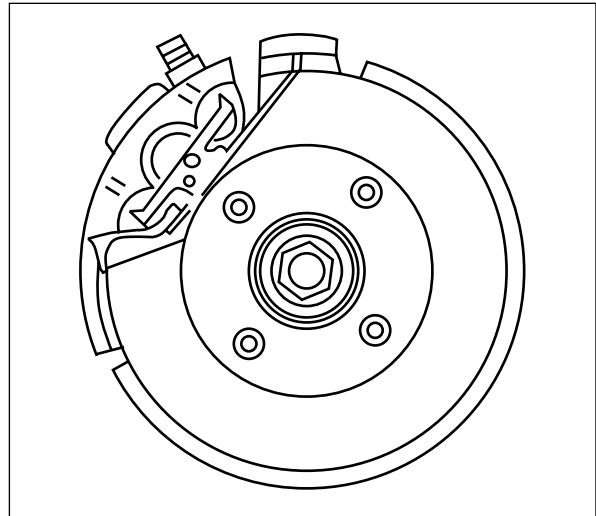
Figure 1 (Left Hand Brake Shown)

Some of the above noted vehicles may experience a "clicking" noise from the front disc brakes during braking. The noise may be present when braking while going forward or reverse. The cause of this noise is inboard pad movement allowed by excessive clearance (wear) between the disc plate and the steering knuckle abutment.

1. Raise the vehicle and remove the tire and wheel.
2. Using the appropriate feeler blades, measure the clearance between the ends of the plate and steering knuckle at both the leading and trailing ends of the plate (Figure 1). Total clearance (both ends combined) should be .006 - .012 inch.
3. If the combined clearance is greater than .012, it will be necessary to remove the inboard pad and using a hammer and punch, make a series of punch marks along the leading end of the plate where it contacts the steering knuckle abutment (Figure 2). This will displace a portion of the pad increasing the overall plate width.
4. Upon installation of the modified plate, check for the correct clearance .066 - 0.12 inch. If insufficient clearance is present, file the ends of the plate to obtain the correct clearance.
