## REAR BRAKE SHUDDER and/or VIBRATION

FORD: 1985-86 MUSTANG, LTD, THUNDERBIRD

MERCURY: 1985-86 CAPRI, MARQUIS, COUGAR

LINCOLN: 1985-86 MARKVII, CONTINENTAL

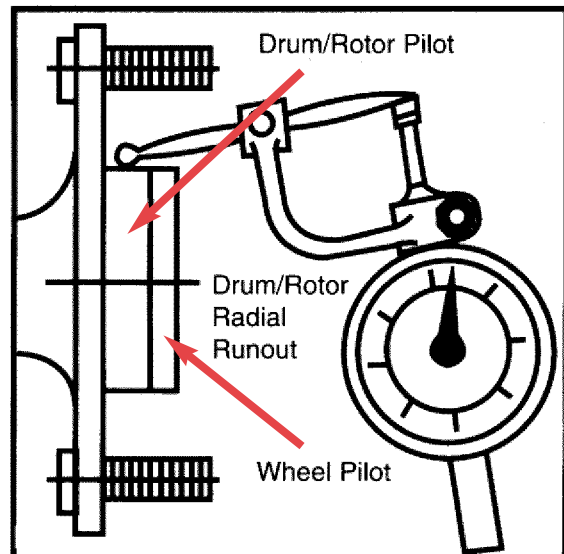
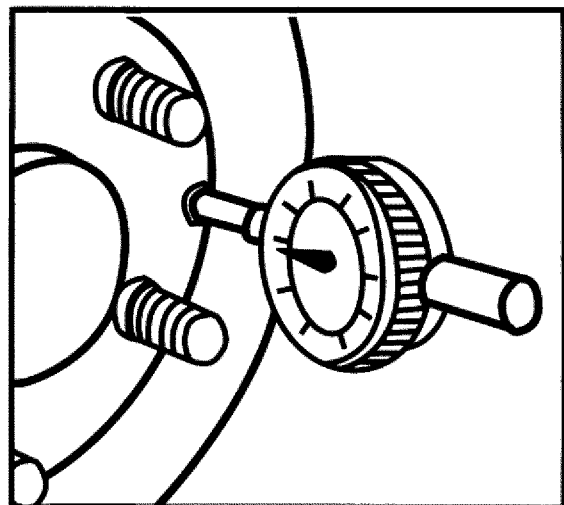
Rear brake shudder and/or vibration may be caused by excessive axle shaft brake drum/rotor pilot runout and/or axle shaft flange face runout. This may be experienced during moderate braking action.

1. Remove the rear wheel and tire assemblies.
2. Remove the push-on brake drum nuts and discard. NOTE: Push-on brake drum nuts are used for shipping only and need not be replaced.
3. Remove brake drum/rotors. NOTE: If vehicle is equipped with rear disc brakes, check the appropriate service manual for proper rotor removing procedures.
4. Mount a dial indicator as illustrated in Figure 1.
5. With the drum or rotor removed, check drum/rotor pilot radial runout. If runout exceeds .007 inch, replace the axle shaft.
6. Reposition dial indicator as shown in Figure 2.
7. Check axle shaft flange face lateral runout. If runout exceeds .010 inch, replace the axle shaft.
