Ford, Lincoln, Mercury 1990 Taurus, Continental, Town Car, Sable Stoplamps Stay on After Stopping

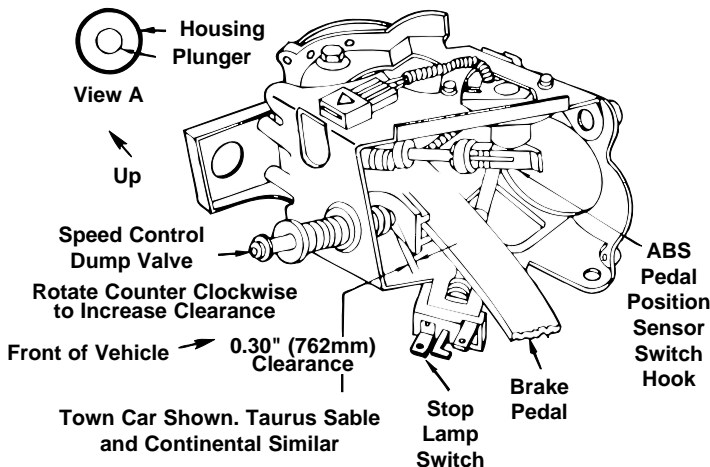
Figure 1

The 1990 Ford Motor Company vehicles listed above may experience a problem with the stoplamps staying on after the vehicle is stopped and the driver has removed his foot from the brake pedal. This is usually caused by a misadjusted speed control dump valve, or the ABS (Anti-Lock Brake System) pedal position sensor may be improperly adjusted.

1. Rotate the speed control dump valve until there is a .030" (.762mm) clearance between the dump valve housing (threaded part of the valve) and the brake pedal contact point (See Figure 1).
 - a. Place a .030" (.762mm) gauge between the pedal pad and the dump valve housing while the brake pedal is in its rearmost position.
 - b. Adjust the valve by turning counter clockwise to increase the clearance or pull the valve body rearward one thread.
