GM "A" Body Cars GM Clip-On Wheel Cylinders

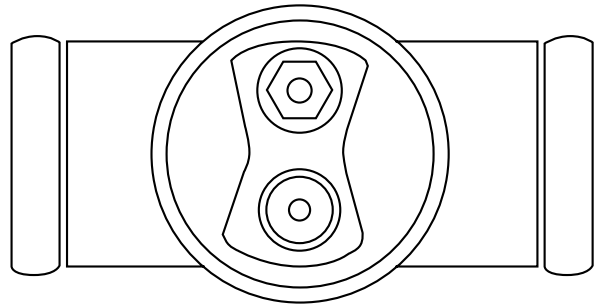
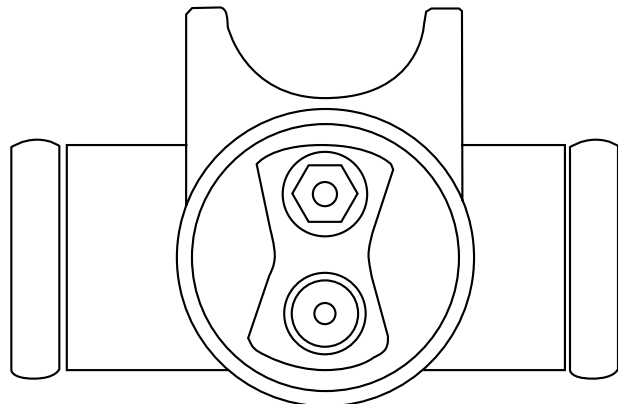
Brake fluid loss and subsequent loss of the rear brakes on GM "A" Body passenger cars (1978-80 Chevrolet Malibu and Monte Carlo, Buick Century and Regal, Oldsmobile Cutlass, and Pontiac LeMans) and "S" Body trucks (1982 Chevrolet S-10 and GMC S-15) may be attributed to rear wheel cylinder rotation due to enlargement of the backing plate pilot hole.

On Canadian vehicles, the backing plate has a tendency to corrode in the wheel cylinder area. As corrosion enlarges the wheel cylinder pilot hole, the wheel cylinder is able to pivot. This in turn allows the wheel cylinder pistons to travel further out in their bore (causing a low pedal), or in severe cases, allowing the pistons to travel completely out of the wheel cylinder causing rear brake failure.

On U.S. models, the same results (rotation of the wheel cylinder) are caused by over-torque of the steel brake line at the wheel cylinder end. Over-torque of the steel line forces the wheel cylinder to rotate in the backing plate under certain conditions, eventually enlarging the pilot hole.

Repair involves using a new design "bow tie" which attaches to the anchor and wheel cylinder to prevent movement of the wheel cylinder. Extreme cases will require backing plate replacement as well.

Repair involves the addition of a clamping device which attaches to the external portion of the wheel cylinder inlet boss and backing plate anchor. A new design wheel cylinder is scheduled for release in the near future, with part numbers listed in the forthcoming HU-800 catalog. This new design cylinder will eliminate the need for the previously mentioned repairs (except on vehicles with extreme backing plate wear, in which case the backing plates will require replacement).
