1984-85 GM "A" and "X" Bodies Engine Cradle Noise

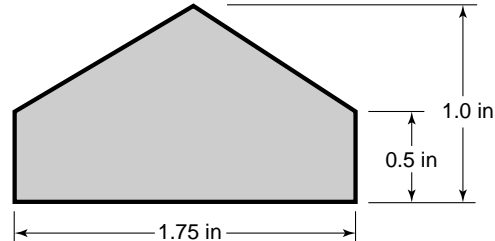
Illustration 1

1984-85 General Motors "A" Body and "X" Body cars may have a "popping" or "crunching" noise during braking or accelerating. In either case, the noise is caused by movement of the cradle assembly, or as a result of loose mounting bolts (torque to 85 Ft. Lbs.) or excessive movement within the cradle mount insulators. If the mounting bolts are properly torqued and the noise persists, it will be necessary to use a shim made from steel or brass shim stock .025 to .04 thick as per Illustration 1.

1. Raise the vehicle and support the cradle with a jack stand or suitable support placed under the rear cross member.
2. Remove one rear cradle bolt only at a time and lower the cradle just enough to eliminate pressure on the cradle mount insulator.
NOTE: ALLOWING THE CRADLE TO DROP EXCESSIVELY MAY CAUSE DAMAGE TO THE STEERING INTERMEDIATE SHAFT.
3. Remove the insulator and install the shim as per Illustration 2.
4. Reinstall the insulator and torque the mounting bolt to 85 Ft. Lbs.
5. Repeat the procedure on the opposite side.
