SERVICE TIPS FOR THE PROFESSIONAL TECHNICIAN

4WAL ABS CODES 61,62, and 63 1992-90 GM LIGHT TRUCKS

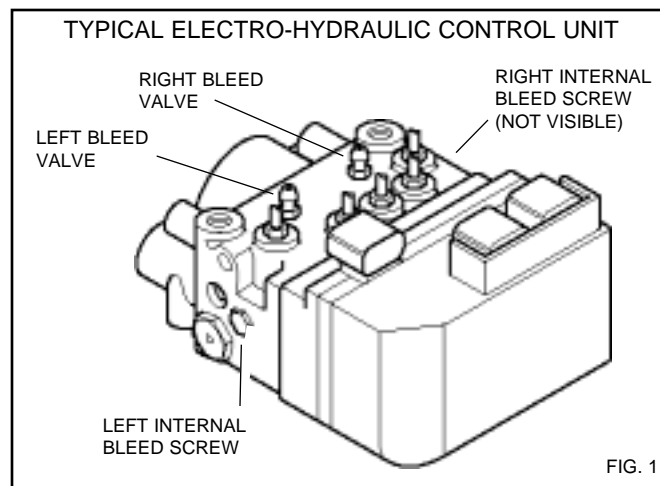
FIG. 1

1990-92 GM light trucks with 4WAL ABS systems can exhibit a code 61, 62, or 63. These codes signal a problem with reset switches which are inside the Electro-Hydraulic Control Unit (EHCU), figure 1. These codes usually occur on vehicles that are three years old, or older.

The codes could be caused by contaminated brake fluid which is allowing debris to flow through the system, or pushing the caliper piston in without opening the bleeder screws. The EHCU can be affected by contaminated fluid because of the very small orifices and passageways. One common problem is for one of the reset switches to become sticky and create a code. If all three codes are present simultaneously, there is probably an electrical ground problem since these switches ground through the brake line. To determine if the contaminated fluid has caused this problem, remove the fluid from the reservoir and look for sediment in the bottom. If sediment is in the bottom of the reservoir, it is also likely to be in the whole system.

Before replacing the EHCU you should attempt to clean the system by flushing and bleeding with brake fluid. If a pressure bleeder is available this is the preferred method. Pressure bleed at 20-25 psi. This will often reset the switch and eliminate the code. Begin by cleaning the bottom of the reservoir. Get as much of the sediment out as possible. Then flush and bleed the entire system. This can require two to three quarts of fluid. **Use only DOT 3 brake fluid.** Always follow the bleeding procedure in the service manual, or ABS manual for the system you are servicing. You will need three valve depressors (F200473). Install one depressor on each High Pressure Bleed Valve and one on the Combination Bleed Valve. After flushing and bleeding perform a function test.

Clear all codes before performing the function test. Use a TECH 1 or jumper key (F121029). Run three tests to get fluid through the EHCU. After the function testing drive the vehicle and perform three to five ABS stops. The code(s) should then be clear. Check the Brake Bleeding Sequence Guide, an ABS manual or vehicle service manual for further information.
