1981 Reliant, Aries, Omni, Horizon Rear Brake Noise

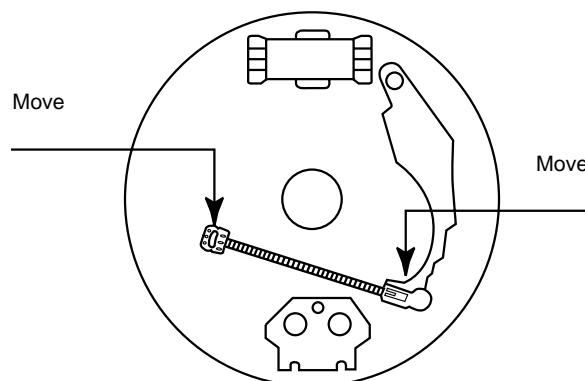
Rear brake noise may be caused on 1981 models by contact between the brake drum and parking brake return spring.

To check for this condition, while the vehicle is on a hoist, spin each back wheel. While it is spinning, grasp the parking brake cable conduit and move it up and down. If this changes the noise, the parking brake cable return spring is contacting the drum.

This condition can be corrected through the following procedure:

1. Remove rear tires, wheels, hubs and drums.
2. Re-position parking brake cable and return spring to the lowest point in the hook end of the parking brake lever.
3. Re-position the opposite end of the spring at the cable conduit clip as far down as possible.
4. Re-assemble the vehicle and test drive. (*Note: Use of a replacement cotter pin that is too long and contacts the grease cap may also cause noise.*)
