1986-1987 Ford Taurus/Mercury Sable Premature Front Brake Wear

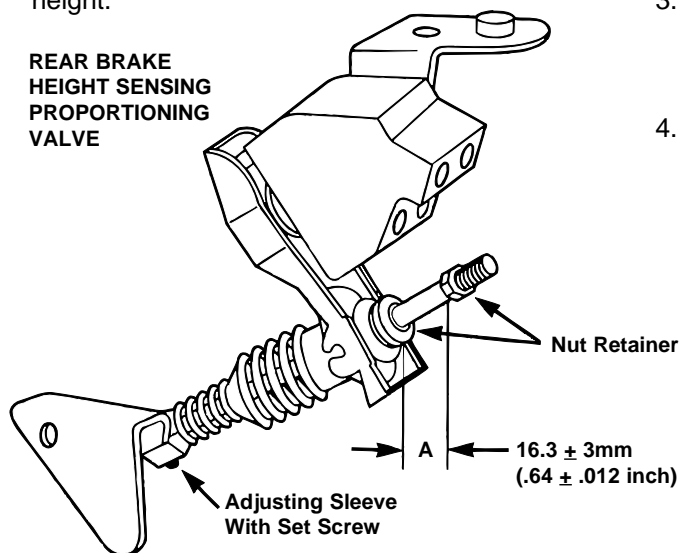
Figure 1

Abnormal front brake wear on a heavy front braking condition may be caused by an improperly adjusted rear height sensing brake proportioning valve. Use the following procedure to check the adjustment of this valve:

1. Drive vehicle on hoist or alignment machine so that it is resting on its wheels at curb height.
2. Measure distance "A" (see Figure 1) between the operating rod upper nut and the retainer in the valve lever. The distance for a nominal setting should be 16.3 & .3mm (.64 & .012 in.). If the distance is outside of these settings, the valve should be adjusted as follows:

- To decrease pressure at rear brakes:
 1. Make sure suspension is at curb height.
 2. Loosen set screw in adjusting sleeve (see Figure 1).
 3. Move adjusting sleeve up - toward valve body on operating rod 1 mm for each 413kPa (60 psi) pressure decrease.

4. Tighten set screw in adjusting sleeve in desired position.
 - To increase pressure at rear brakes:
 1. Make sure suspension is at curb height.
 2. Loosen set screw in adjusting sleeve (see Figure 1).

3. Move adjusting sleeve down - away from valve body on operating rod 1 mm for each 413kPa (60 psi) pressure increase.
 4. Tighten set screw in adjusting sleeve in desired position.
