WAGNER[®] Brake Fax #62

CALIPER SEIZURE 1991 and later GENERAL MOTORS APV VEHICLES

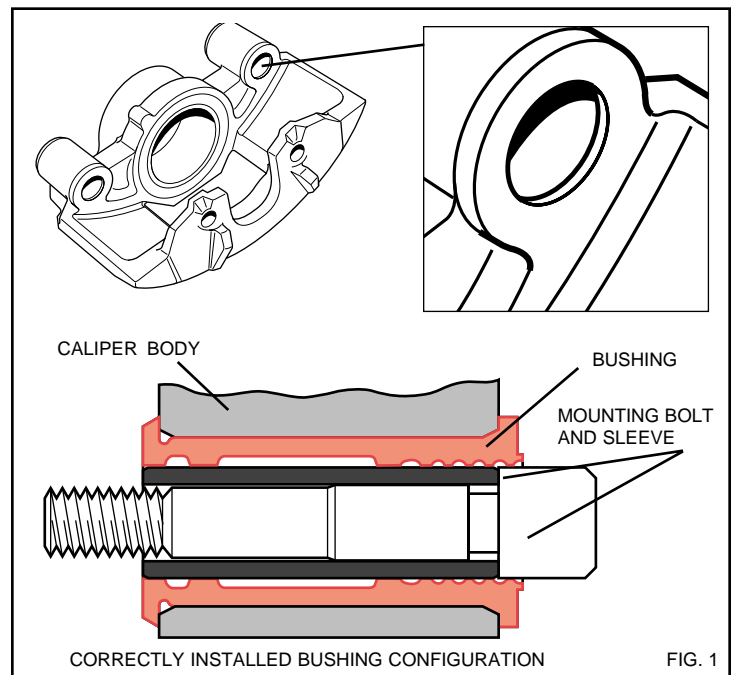
The caliper on these vehicles is a single piston floating type. The caliper mounting uses a combination of a bolt and sleeve assembly and bushing. The bushing acts as an insulator. The inside of the bushing should be coated with silicone lubricant when assembled which allows the caliper and bushing to move freely on the mounting bolt and sleeve, figure 1.

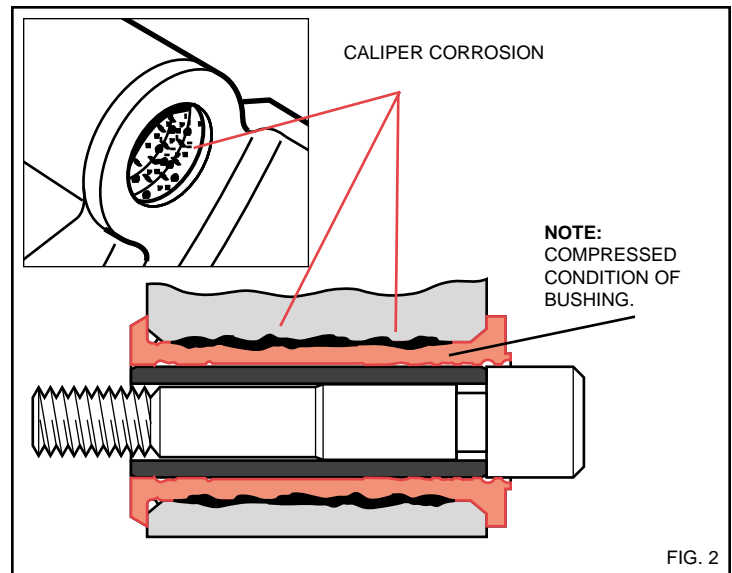
When corrosion occurs between the bushing and caliper housing, it can compress the bushing to the point where the assembly will no longer slide properly during brake application. The caliper is then seized in position.

If new hardware (bushings and bolt/ sleeves) is installed and the caliper housing surface is not clean and smooth, caliper movement will again be restricted. The corrosion can reduce the area necessary for the bushing. The bushing may be compressed enough to prevent caliper movement, figure 2.

If the caliper is to be reused, the area inside the caliper ears must be clean and smooth. The bushing should also be lubricated with silicone lubricant during installation.
