WAGNER[®] Brake Fax #2

1984 Oldsmobile Cutlass Ciera Low Vacuum Condition

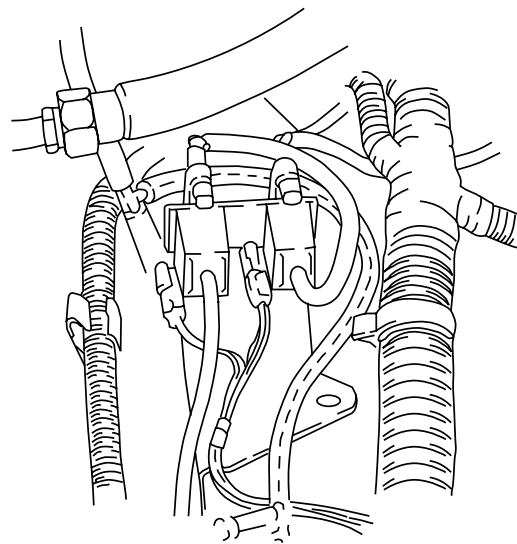
Some 4.3 L V-6 Federal Version 1984 Oldsmobile Cutlass Ciera models may experience a low vacuum condition causing the brake warning light to come on, particularly at idle. These vehicles are equipped with a low vacuum sensor at the vacuum booster and a belt driven vacuum pump. The low vacuum condition and subsequent brake warning light illumination may be caused by abrasion wear of the vacuum hose between the vacuum regulator and "tee" fitting.

If this condition exists, replace this portion of the hose with a 13-1/2" length of 7/32 vacuum hose after rotating the "tee" fitting to aim at the left front headlamp. The vacuum hose should then be routed in front of the EGR valve as illustrated below (dotted line).
