# WAGNER® Brake Fax #31

## 1989-90 Pontiac Grand Prix, Buick Regal, Oldsmobile Cutlass Supreme Delco Moraine ABS Diagnostics

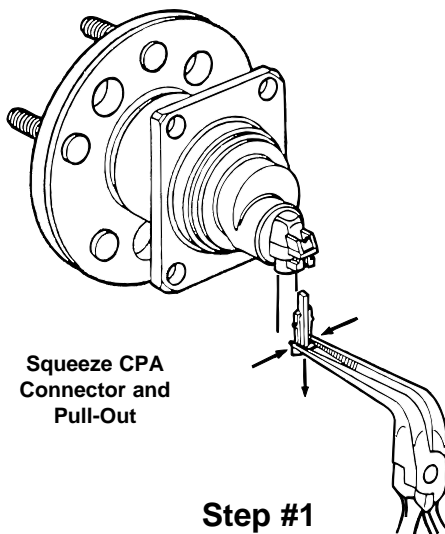
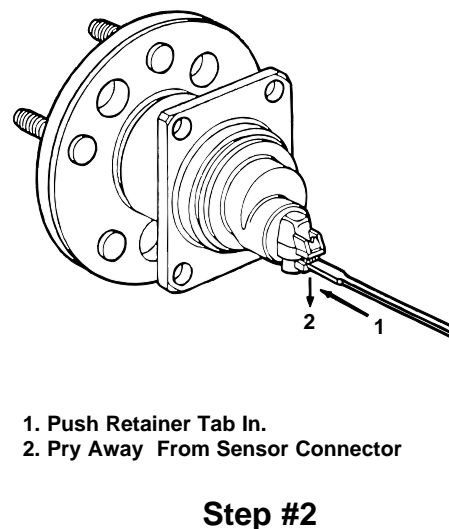
If a vehicle does encounter this condition, both rear wheel bearing assemblies should be replaced. The new bearings have an improved seal. When removing the ABS electrical connector, refer to the following illustrations to insure against damaging any part of the connector which uses CPA (Connected Position Assurance) locking pins.

The ABS sensor is not serviced separately. You must replace the rear wheel bearing assemblies with General Motors part number 7466987 bearings.
