REAR BRAKE DRUM REMOVAL 1992 TOYOTA CAMRY

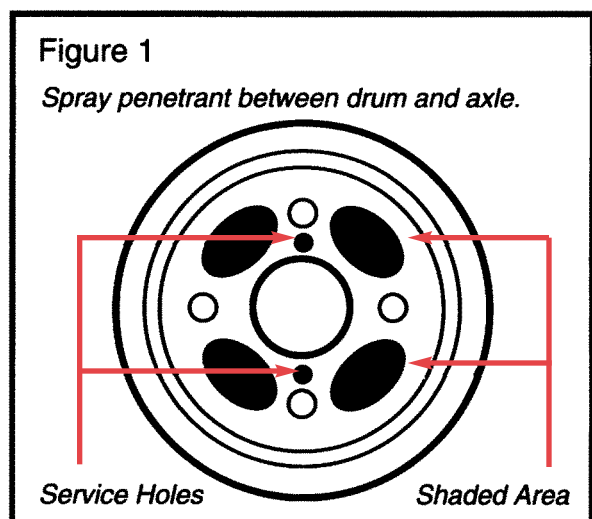
Many technicians have commented on the difficulty of removing the rear brake drums on 1992 Toyota Camrys. This condition is usually due to a rust build up between the axle hub and brake drum.

1. Apply rust penetrant to the drum and axle area (Figure 1).
2. After allowing the penetrant to soak, screw two bolts (10 mm with 1mm thread size) into the service holes (Figure 1) to back the drum away from the axle hub.

after completing step 2, gently strike only the shaded areas shown in Figure 1 with a plastic mallet.

NOTE: DO NOT STRIKE ANY PORTION OTHER THAN THE INDICATED SHADED AREA. THIS MAY CAUSE DAMAGE TO THE BRAKE DRUM.

After brake drums have been removed and prior to installation, remove all rust from the rear axle shaft and brake drums with sandpaper. Also, it is suggested to apply a thin coat of a high temperature type grease between the rear brake drum and the axle shaft.
