## 1988 AND LATER GM "C" AND "K" TRUCKS

### CLUTCH MASTER CYLINDER FAILURE

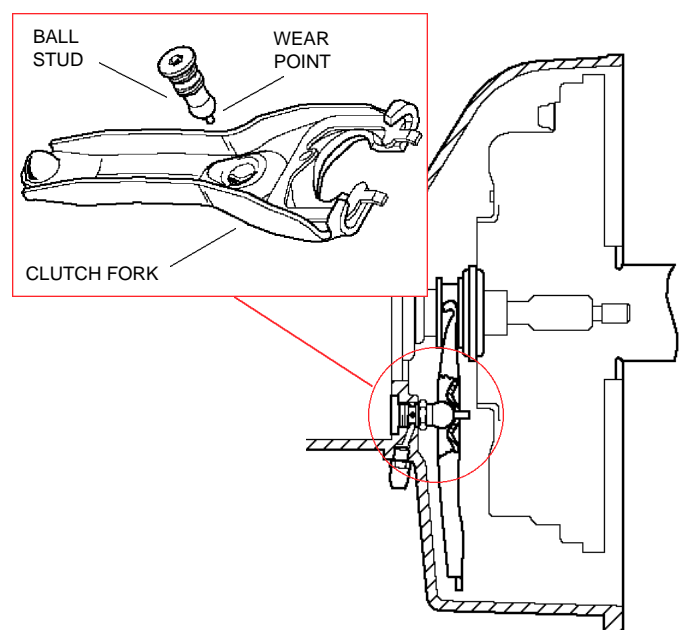
TYPICAL CLUTCH MASTER CYLINDER

The clutch master cylinder can break due to excessive pressure buildup. The break can begin as a small crack creating a leak, which can later develop into a visible crack in the master cylinder housing. This is often mistakenly diagnosed as a defective master cylinder, especially after repeated failures.

The most common cause has been reported to be a binding clutch fork, or throw out lever. If the area of contact between the ball stud and the clutch fork is binding, from lack of lubrication, hydraulic pressure in the clutch system can rise substantially. Excessively high pressure can cause the master cylinder to leak.

If there is a squeaking in the clutch fork or increased pedal resistance the ball stud and clutch fork should be inspected and lubricated or replaced. General Motors has released a bulletin pertaining to a squeaky clutch problem on 1994-95 vehicles.

The ball portion of the ball stud should be coated with high temperature grease. The ball stud should then be packed with grease from the grease fitting, if equipped. The grease fitting may not be readily visible on high mileage vehicles and may require cleaning away of road dirt to make the fitting visible and serviceable.
