84-88 Escort, Tempo, 84-87 Lynx 84-88 Topaz Clicking in Front Disc Brake

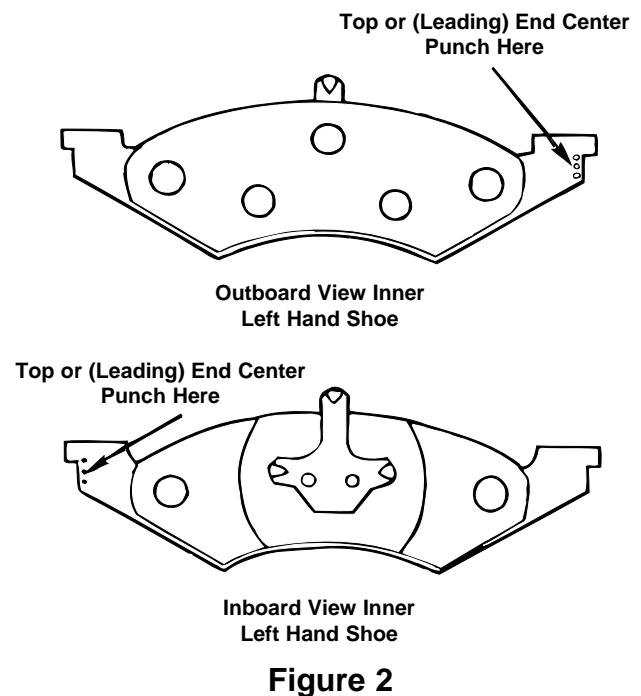
A "clicking" noise from the front disc brake area of the above mentioned vehicles can be heard. This may be caused by too much clearance between the steering knuckle abutment and the inner disc brake pad. To reduce the clearance between the steering knuckle abutment and the inner disc brake pad you will have to modify the inner disc brake pad.

1. Use a feeler gauge and measure the clearance between the steering knuckle abutment and the inner disc brake pad at the top (leading) and bottom (trailing) ends as shown in Figure 1.
2. Add the clearance readings together. The sum should be between .006 - .012 inch (.015 - .030 cm.).
3. If the total clearance is greater than .012 inch (.030 cm.), remove the inner disc brake pad from the caliper. Refer to the appropriate service manual for service details.
4. Center punch the inner disc brake pad at the inboard and outboard side of the top (leading) end, see Figure 2.
5. If the inner disc brake pad will not seat properly in the steering knuckle abutment opening after it has been center punched, file the edge of the center punched pad until a total clearance of .006 - .012 in. (.015 - .030 cm.) is obtained.
