ABS WARNING LIGHT ALL BMW's WITH ANTI-LOCK BRAKES

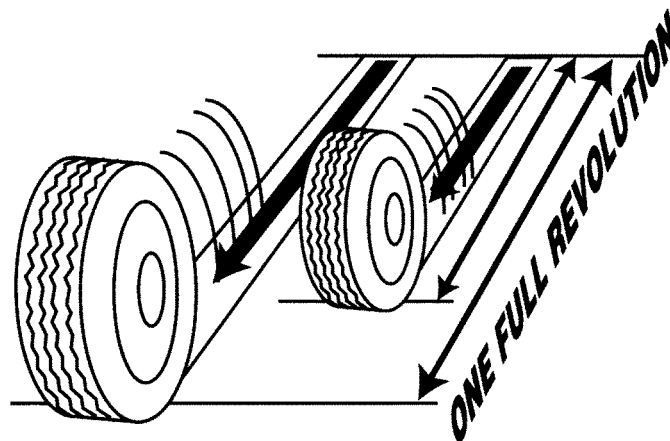
Size is the most important factor to check. Differences in tires may cause enough variance in rolling circumference (see illustration) to confuse the ABS control unit, which in turn may give a false signal to the ABS warning light. This especially holds

true when snow tires are mounted on the rear and they have substantially more tread than the front tires.

The anti-lock brake system (ABS) warning light may come on intermittently and normal troubleshooting procedures may not indicate any defects. This problem may occur when the vehicle is driven over 50 mph, or on cars that have recently had two new tires or snow tires installed. Check all four tires on the car to make sure that they are the same brand, tread design and size.
